# Eelgrass and Waterbirds in Richardson Bay

Habitat and Wildlife Monitoring – June 2022

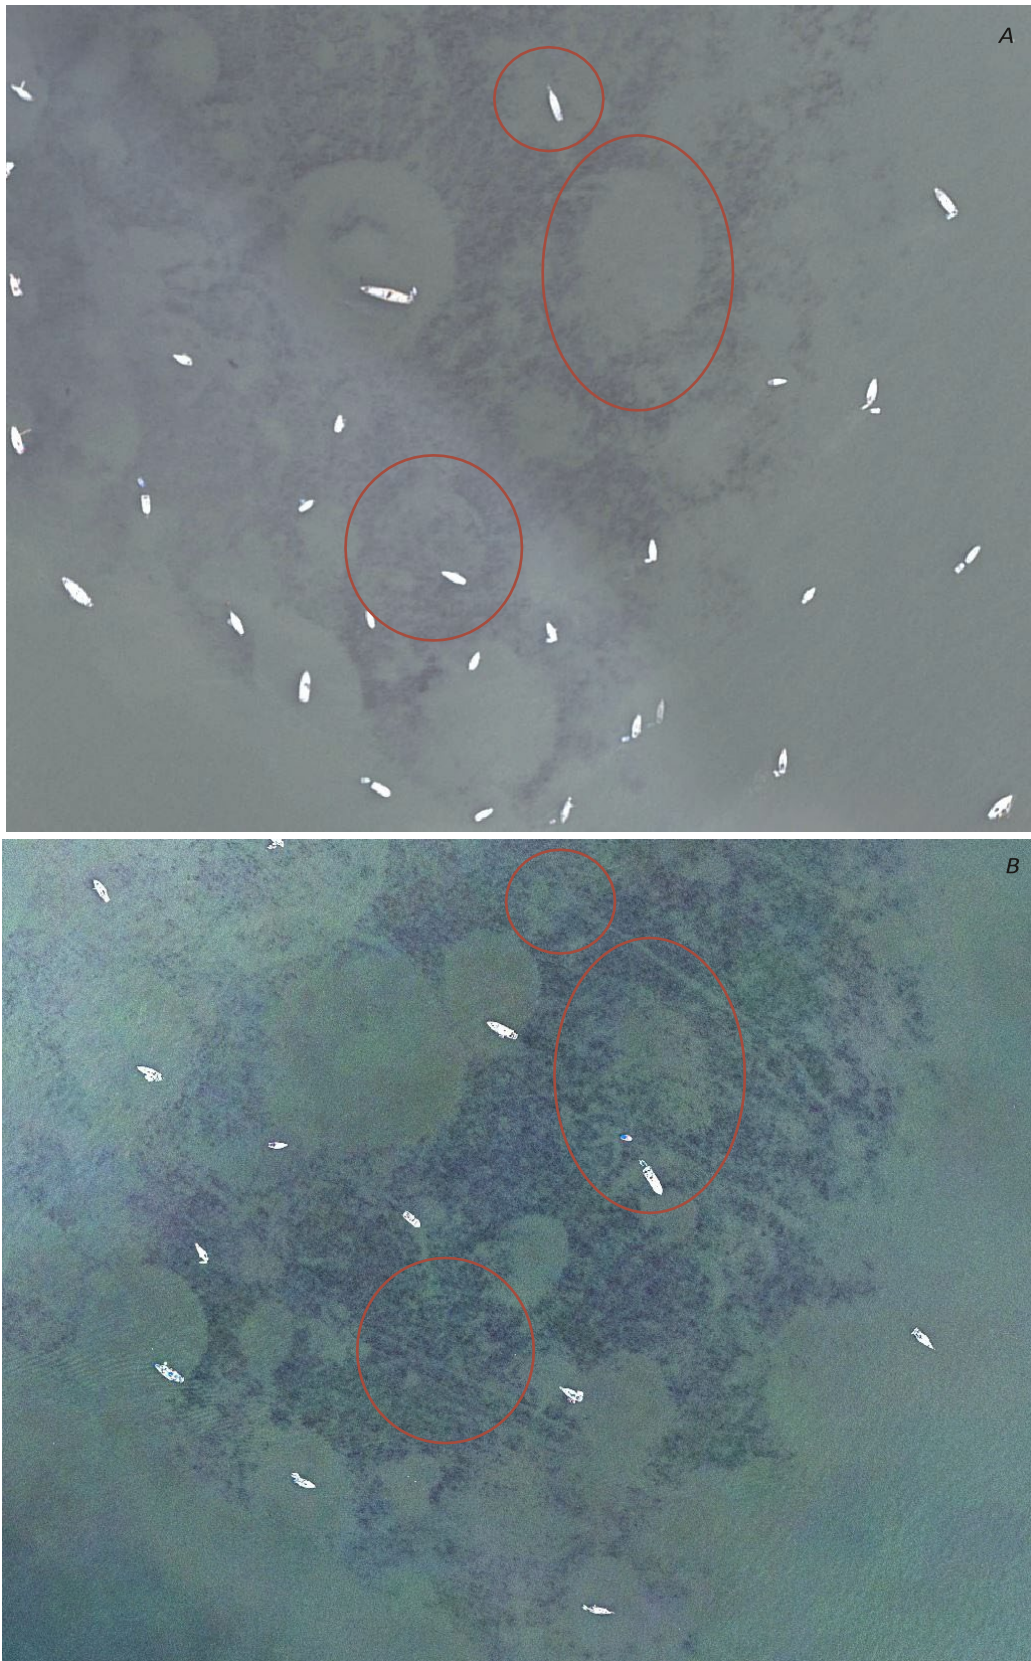
Figure 3. Examples of anchor scars in Richardson Bay eelgrass bed from 2017 (above) that scars that appear to have begun to recover in 2021 (below).

However, by comparing the imagery across the two separate study years, there are a few instances where the removal of an anchored-out vessel resulted in the recolonization of eelgrass in a previous scar. One clear example of eelgrass growth in a previous scar can be found in Figure 3. Revegetation of old scars appears to have occurred in areas where the adjacent eelgrass bed is densely vegetated. Scars where the surrounding eelgrass is sparse and patchy did not appear to revegetate as successfully.

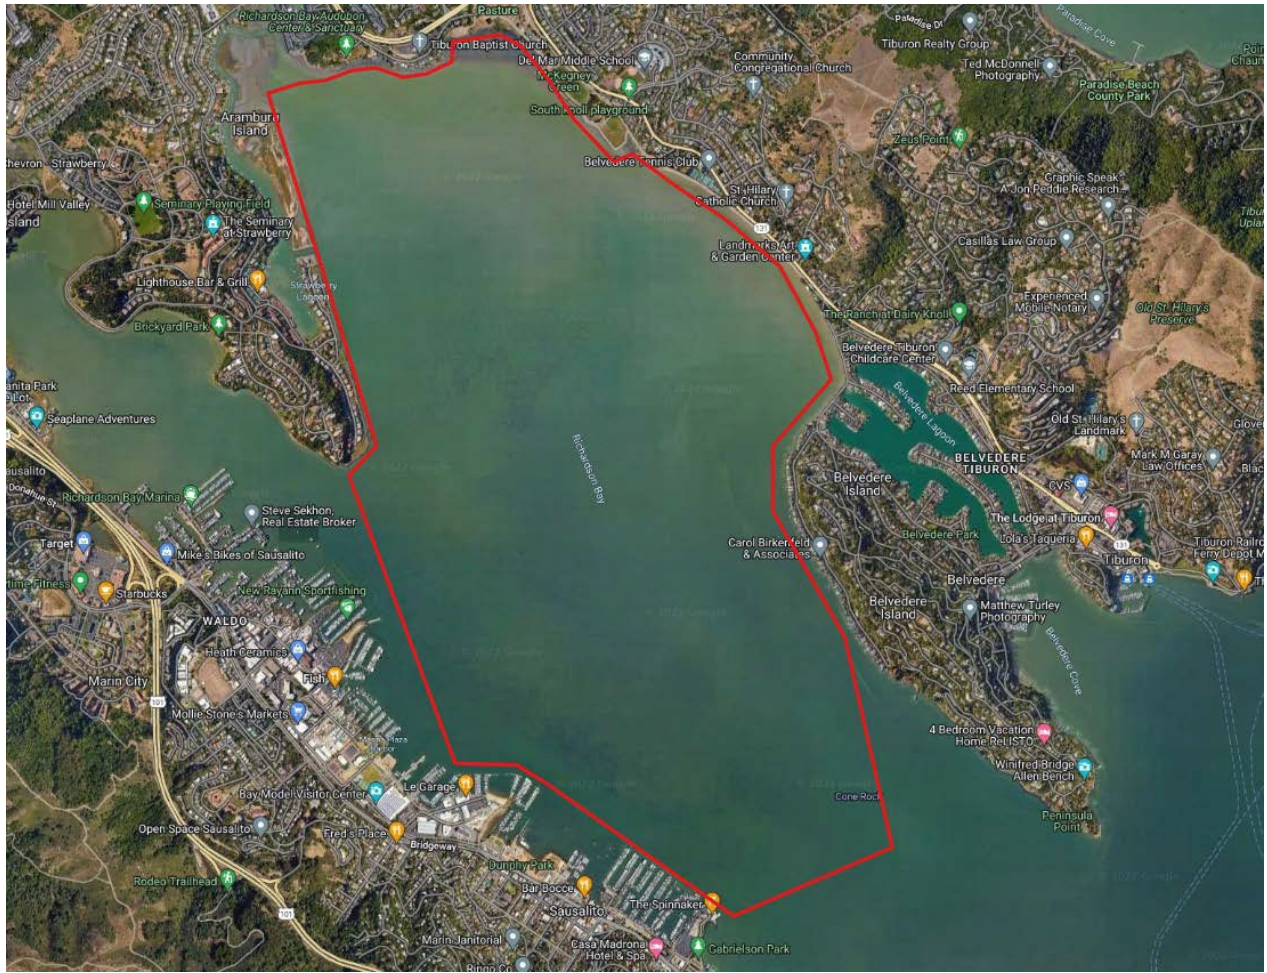
Figure 4. Monitoring extent for drone flights assessing rafting waterbird usage of Richardson Bay.

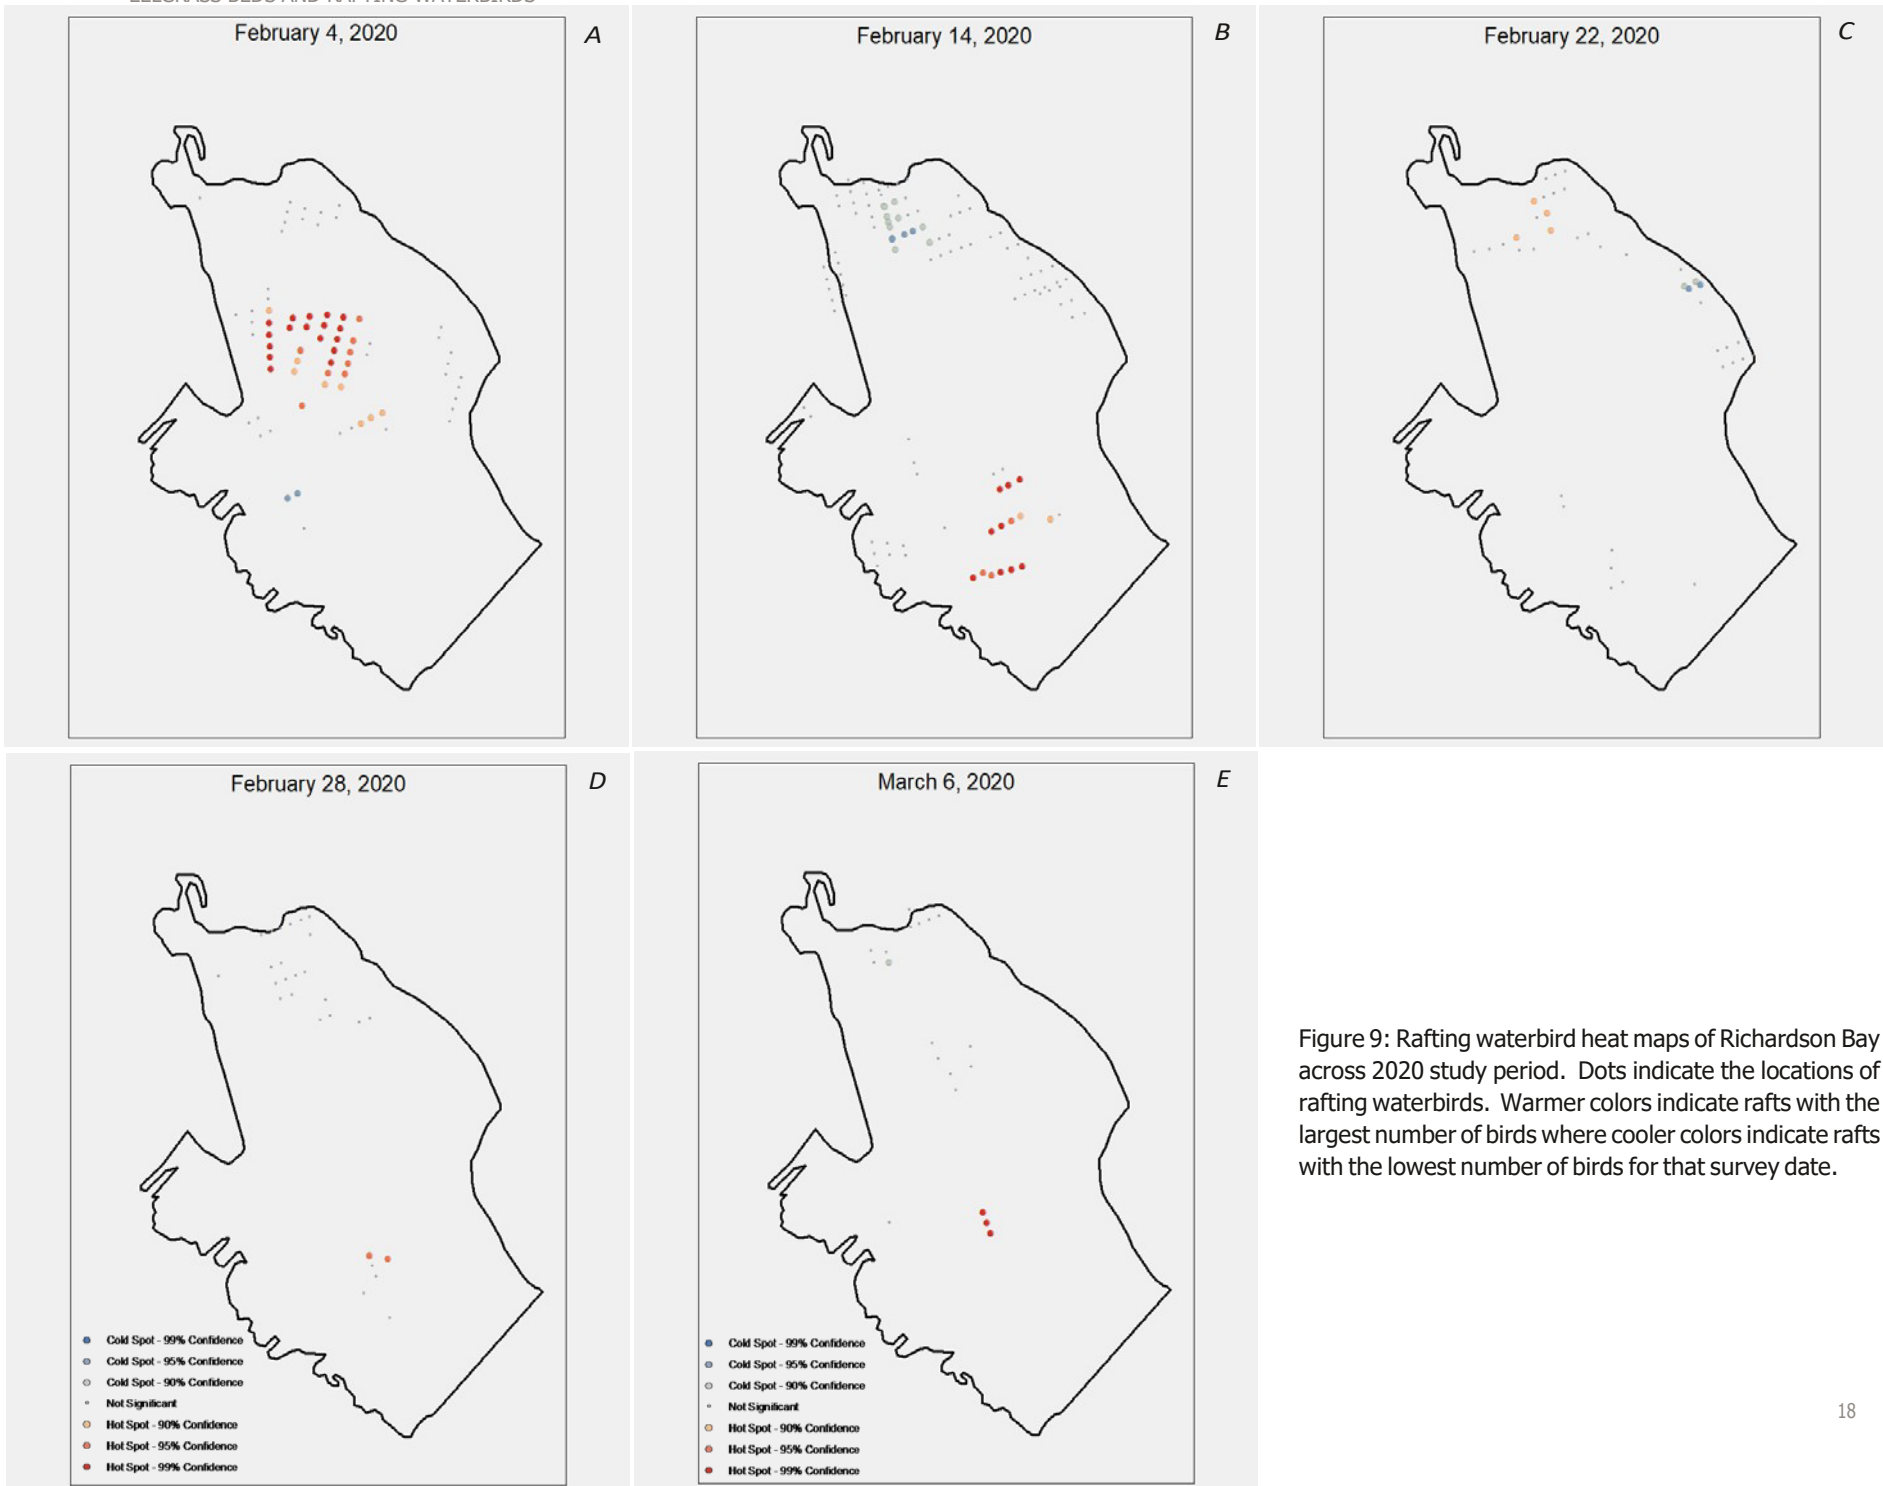
Figure 9: Rafting waterbird heat maps of Richardson Bay across 2020 study period. Dots indicate the locations of rafting waterbirds. Warmer colors indicate rafts with the largest number of birds where cooler colors indicate rafts with the lowest number of birds for that survey date.

rafts closer to the middle of the bay tended to contain higher number of birds compared to rafts closer to the coast (Figure 9).
