Richardson's Bay Regional Agency

Ecologically-based Mooring Feasibility Assessment and Planning Study

November 2019

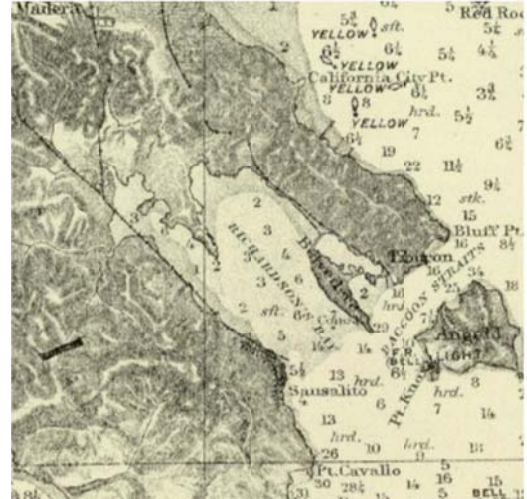
Richardson's Bay remained in some use on maps in the early part of the twentieth century as indicated in this 1908 Earthquake Investigation Commission map.

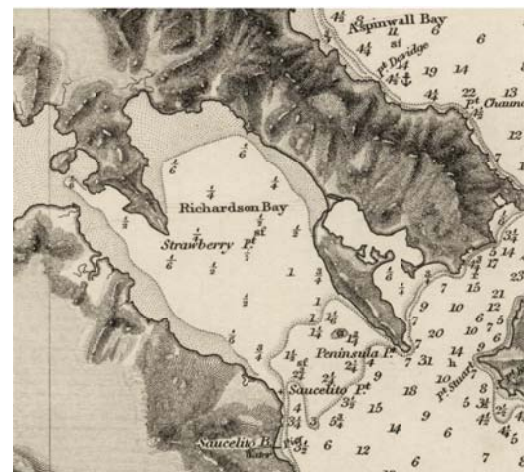
San Francisco Harbor surveyed by Lt. James Alden, U.S. Navy 1856 (published by British Admiralty, London). Soundings are in fathoms.

Creek. The channel, while not easy to detect from the point sounding map of 1859 curved around Strawberry point and extended slightly northward and then south to the bay within the eastern lobe of the bay where it crossed the bay to the east and hugged Belvedere Island traveling to the deeper waters of the bay in Raccoon Strait. This channel formed during a period when sea level was lower and the creek crossed a shallow flat valley.

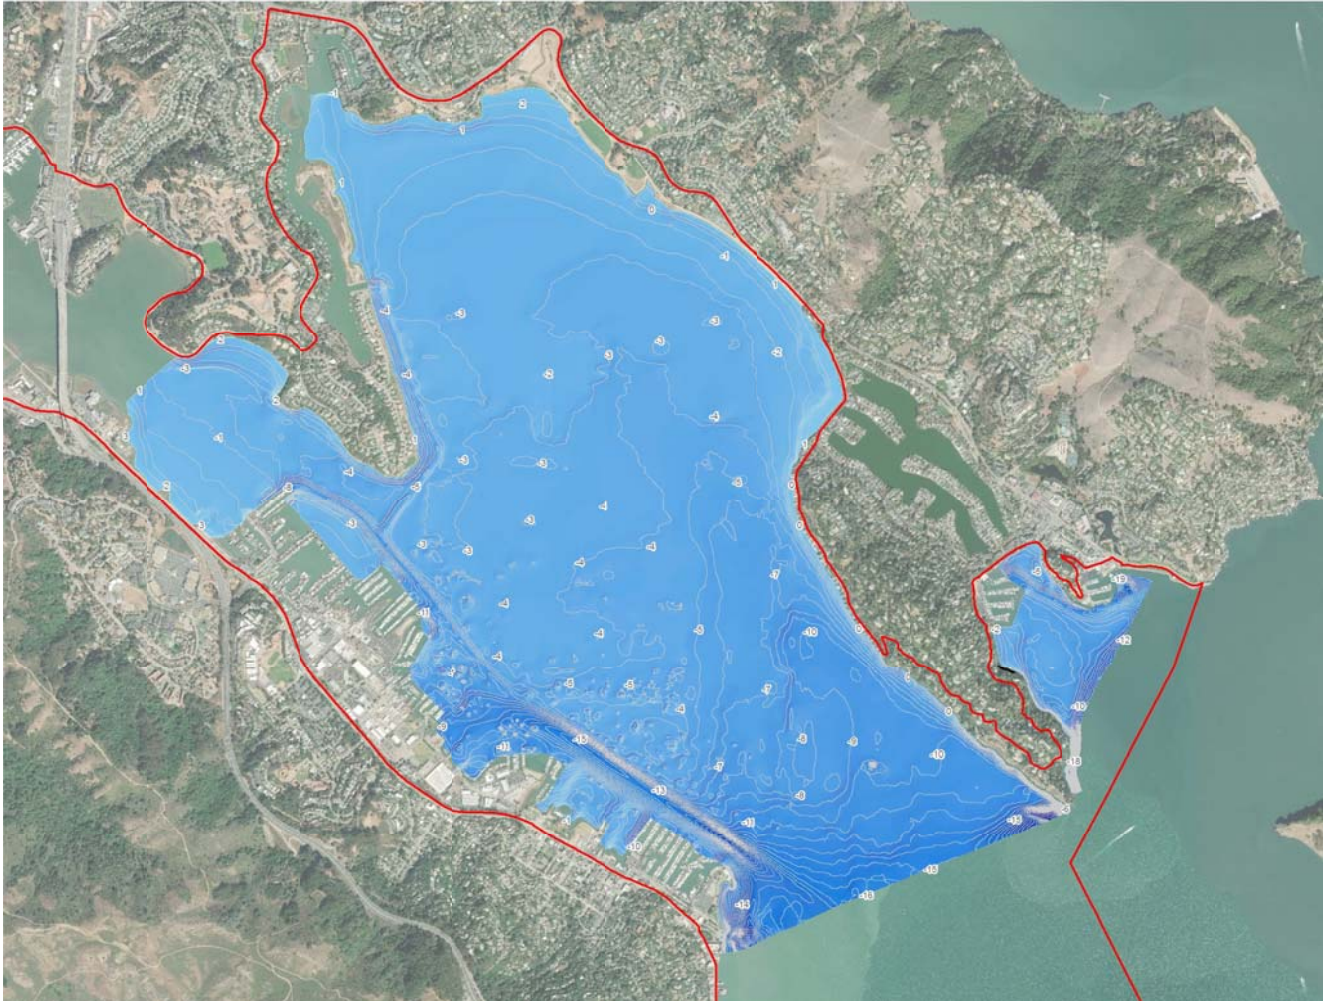
Figure 3. 2019 Richardson Bay bathymetry.

Bathymetric surveys reveal an extremely shallow and flat bottom embayment over most of the bay with a gentle slope to the southern end of the bay where the bay falls abruptly to the deeper waters of San Francisco Bay. Dredged channels are the most notable topographic features followed by scour pits at the western side of Strawberry Point and those derived from moorings on the otherwise featureless flats (Figure 3). Within the inner portions of the bay, some areas have a slope ratio of less than 1 foot of fall in more than a half mile of distance.

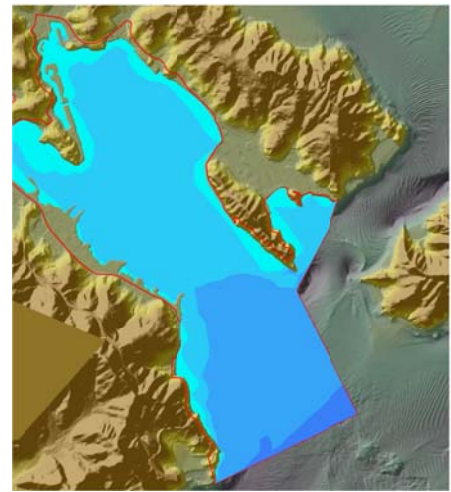
1-year maximum wave model results

As anticipated the results of the OCOF modeling suggest that the annual peak wave environment within Richardson Bay is of a relatively low amplitude with the maximum annual (1-year) wave heights of 3 feet being reached near the eastern shoreline of the southern end of the bay where wind fetch, water depth, and wave penetration from the deeper waters to the south are at their maximum. Similar to the conditions of the 1-year wave environment, the 20-year and 100-year maximum wave conditions follow the same pattern with the greatest wave conditions being expressed at the south end of the bay. Within Richardson Bay a 20-year event produces a maximum modeled wave height of 5 feet. A 100-year event produces a maximum modeled wave height of 8 feet. However with the 100-year wave environment, the deeper Army Corps dredged channel is modeled to promote a greater penetration of large waves along the Sausalito side of the bay. This is a condition not seen in the 1-year and 20-year model results. In all modeled scenarios an erroneous anomaly exists in the model at the upper end of the bay near the Highway 101 Bridge.

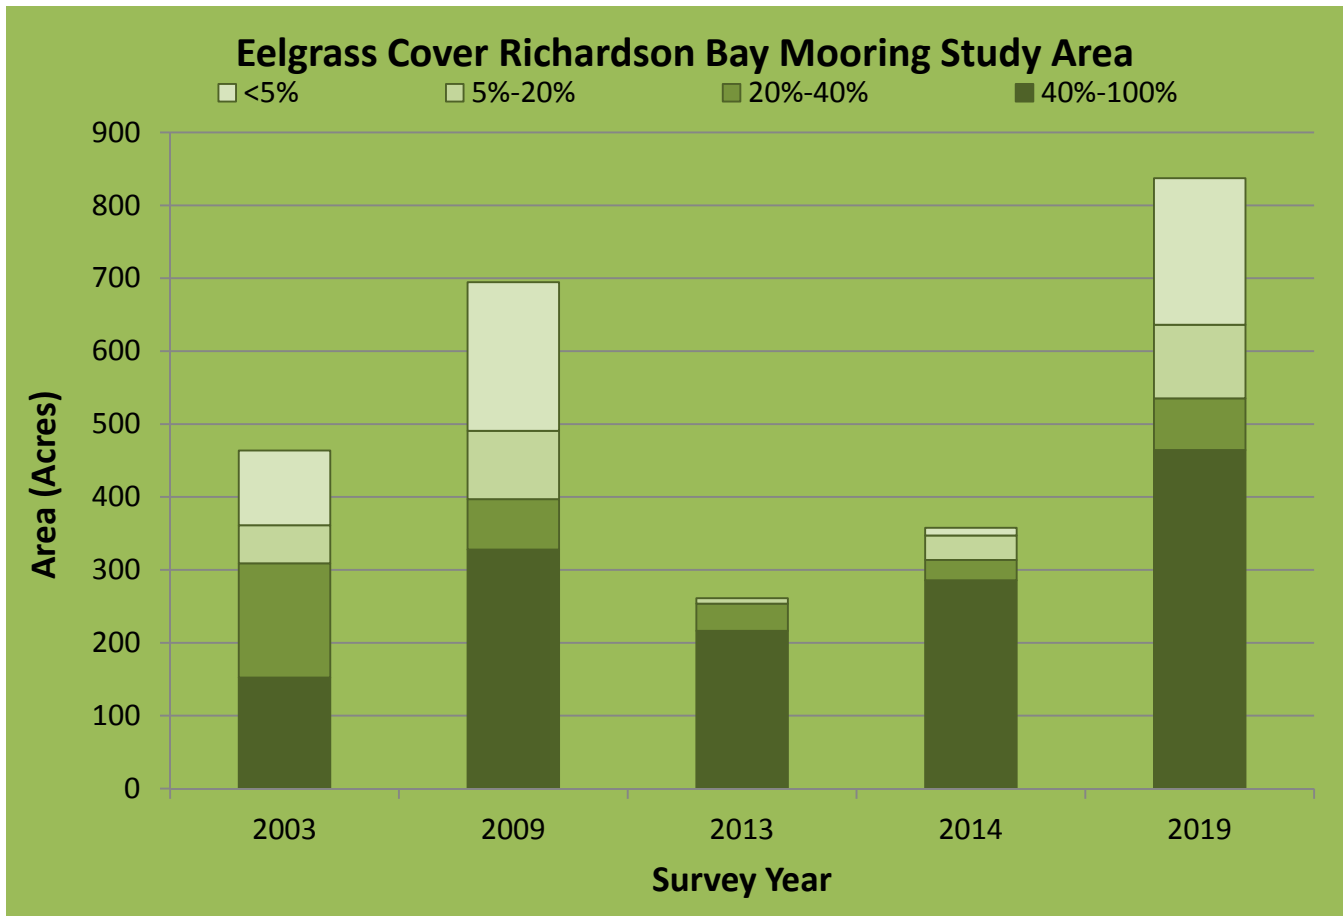
Figure 6. Eelgrass distribution within Richardson Bay Mooring Study Area inclusive of Richardson Bay and Belvedere Cove for comprehensive survey years. Eelgrass bottom coverage is defined as the openness of the eelgrass plants distributed across the bayfloor. A 20%-40% eelgrass bed means that within this portion of the beds a random sampling by dropping a 1 meter quadrat would be expected to hit eelgrass 20-40% of the time.

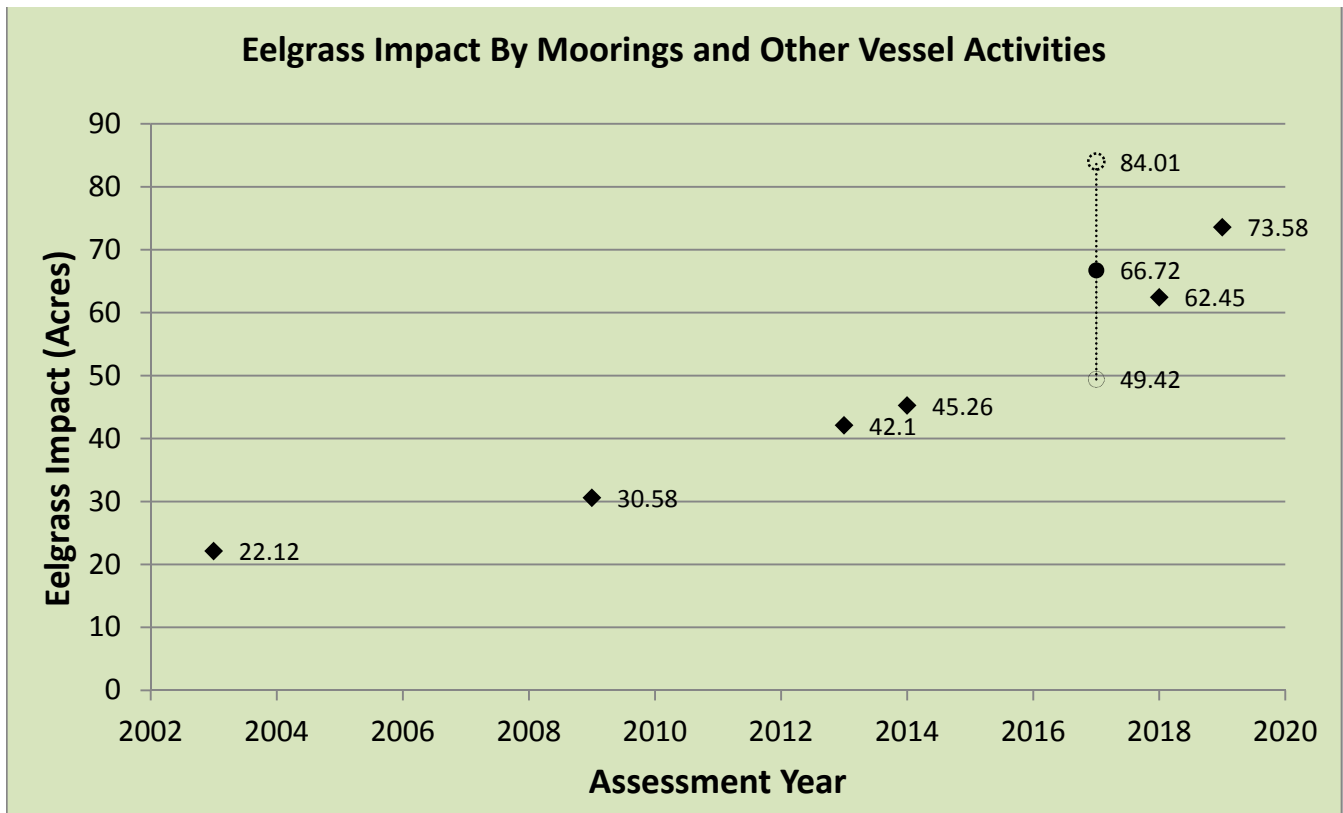
Figure 12. Change through time of eelgrass impact area as a result of moorings, vessel grounding and propeller wash. Data are derived from eelgrass surveys and mapping using acoustic sonar and aerial photographic interpretation completed under this study with an additional estimate for 2017 derived from work by Audubon California (Kelly et al. 2019).

In addition to mapping of the spatial extent of eelgrass impacts (Figure 11), a quantification of eelgrass impacted by vessels was undertaken (Figure 12). This chart illustrates an increasing trend of greater eelgrass impacts from vessel activities over time. In 2003 impacts to eelgrass were quantified at approximately 22 acres and by the present 2019 survey eelgrass impacts were quantified to be nearly 74 acres.

The trend toward increasing eelgrass damage in recent years is the result of many factors including expanding numbers of vessels on moorings, changing make up of vessels on moorings, and changing distribution of vessels and eelgrass. It is also possible that sediment accretion and reduction of water depths within the inner portions of the Bay is playing a role in increasing damage; however, this is not clear since the history of accretion over time has not been ascertained.

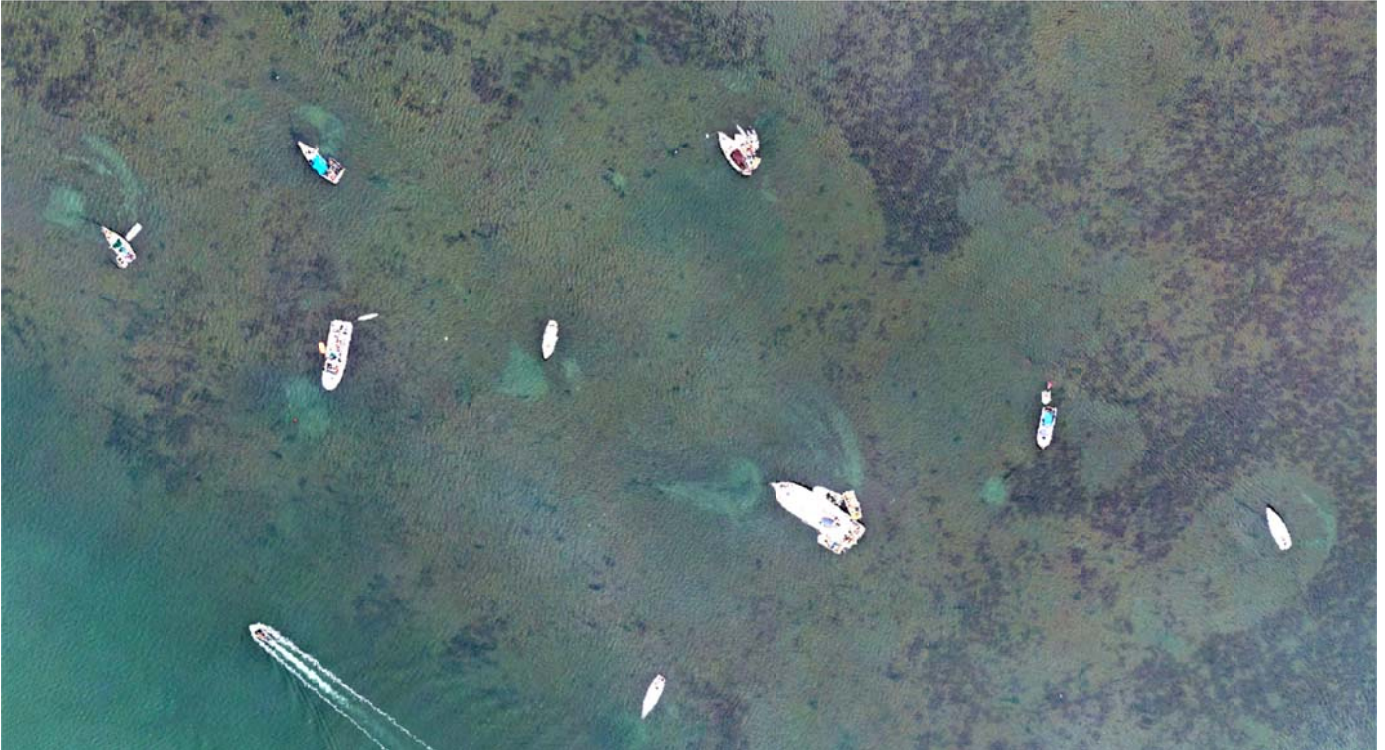
Eelgrass damage from mooring ground tackle dragging and vessel grounding drags at low tides. The dark mottling is eelgrass, the brownish tinge is a diatom film on the bottom and the bluegreen color is unvegetated silt and clay from recent disturbance. (Photograph taken June 2019)

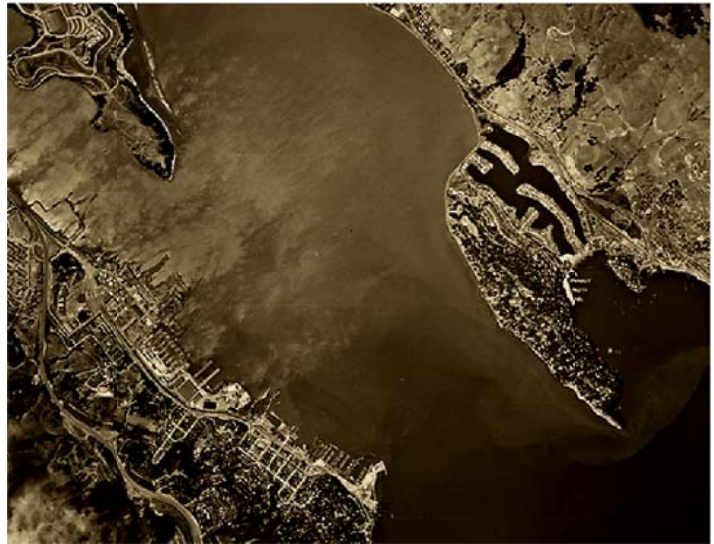
Richardson Bay May 1958 shows different distribution of moorings than occurs today. The northwestern end of the bay has a number of moorings, assumed to be houseboats, Belvedere Cove had considerable moorings, the Sausalito waterfront had moorings where many marinas are present today, and a few moorings occurred in the central portion and near the far southern end of the bay.

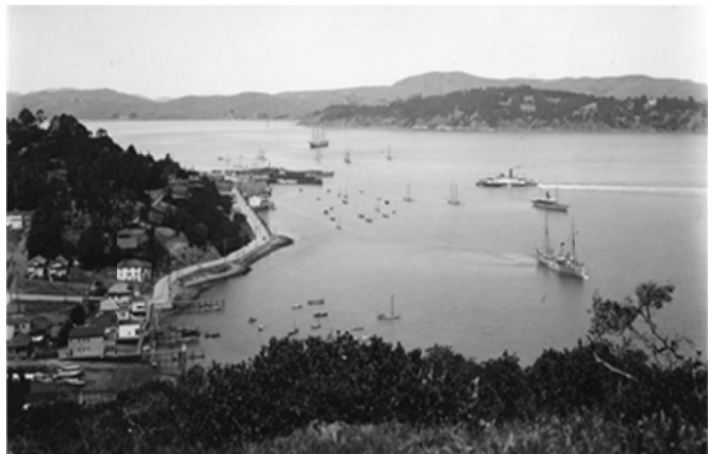
Richardson Bay May 1916 showing a history of vessel mooring at the extreme southern portions of Richardson Bay between Anchor Street and South Street, Sausalito. (Derived from Kelly et al. (2019) originally referenced to the Anne T. Kent Room of the Marin County Library)

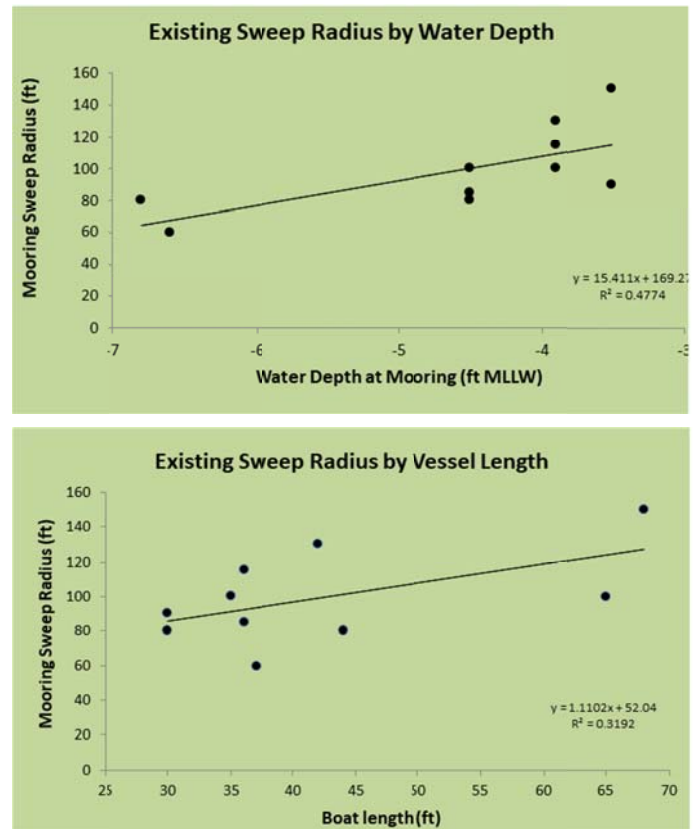
Figure 15. Relationship between sweep radius water depth and vessel lengths within Richardson Bay mooring sampling

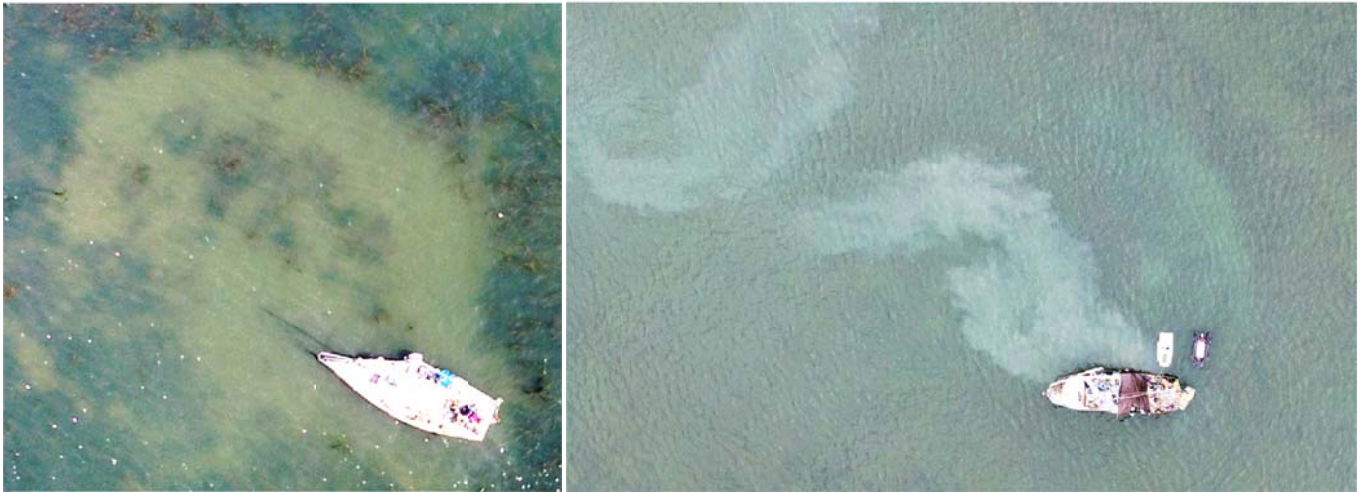
Sweep radius illustrating concentric impact areas of ground tackle on the inner portion of the sweep and keel drags on the outer portion of the sweep (left). Low tide turbidity plume generated from vessel grounding at the outer margin of the sweep radius. Note the vessel keel drag scar on the bottom above dinghies in photograph (right).

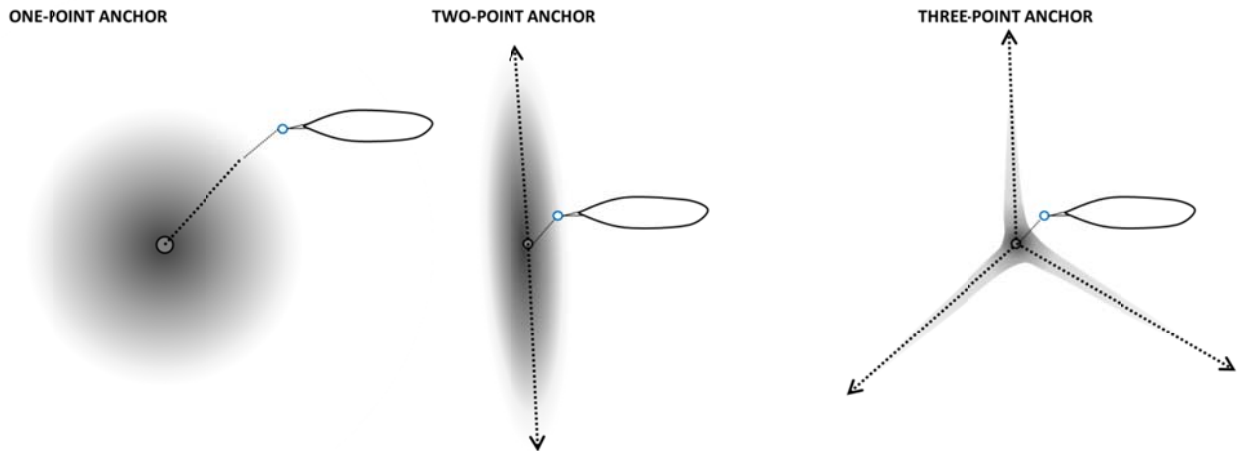
Figure 17. Conventional ground tackle anchor scarring. Typical configuration of conventional ground tackle anchors result in diminishing benthic ecosystem damage with increasing points of anchoring.

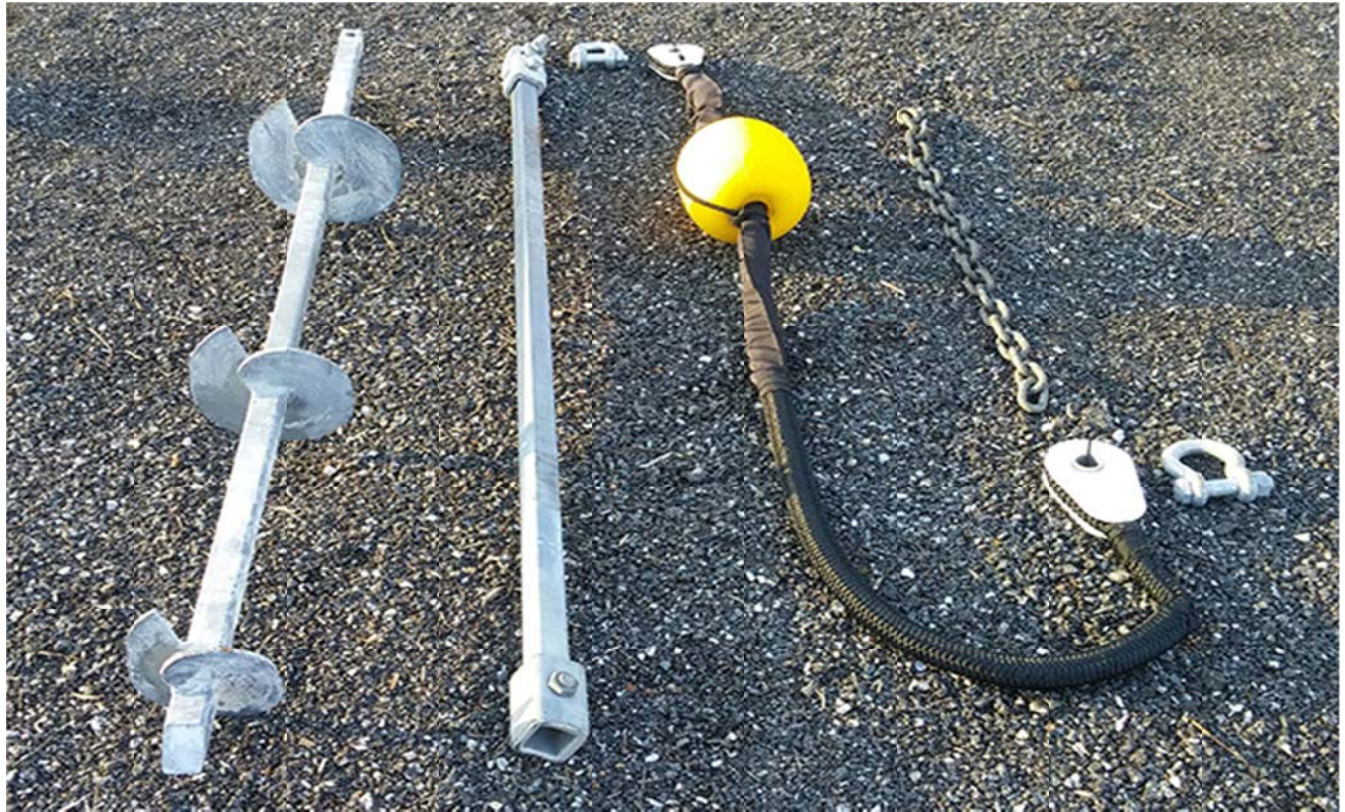
Eco-mooring SYSTEM | 603.672.1751 | dmerill@boatmoorings.com

Mooring Systems for Sensitive Seabeds

Examples of differing systems and components are displayed in this section. Manufacturers, distributors, and installers often interchange different system components to meet particular application needs. This interchangeability of parts, as with conventional moorings provides flexibility in design; however, it also creates potential for untested pairings and potential points of failure. For this reason, any mooring system considered, of a conventional or conservation mooring type, should be engineered for the particular application and installed and maintained by a qualified party. Common manufacturers or vendors of conservation moorings, mooring systems, and mooring components include, but are not limited to the following:

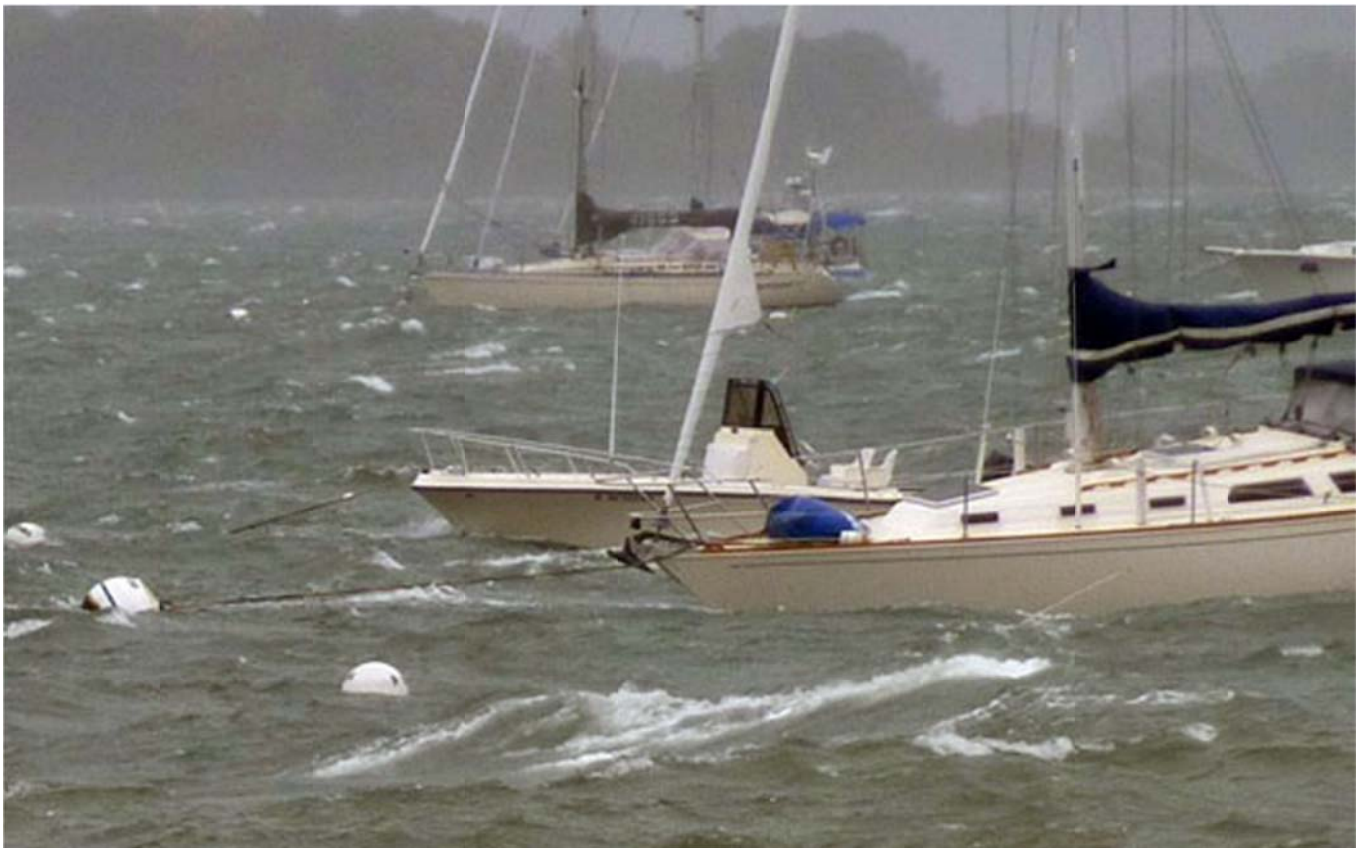
Elastic mooring rode and storm pendants can provide a reduction in jarring impacts under severe storm conditions (photo from ecomooringsystems.com)

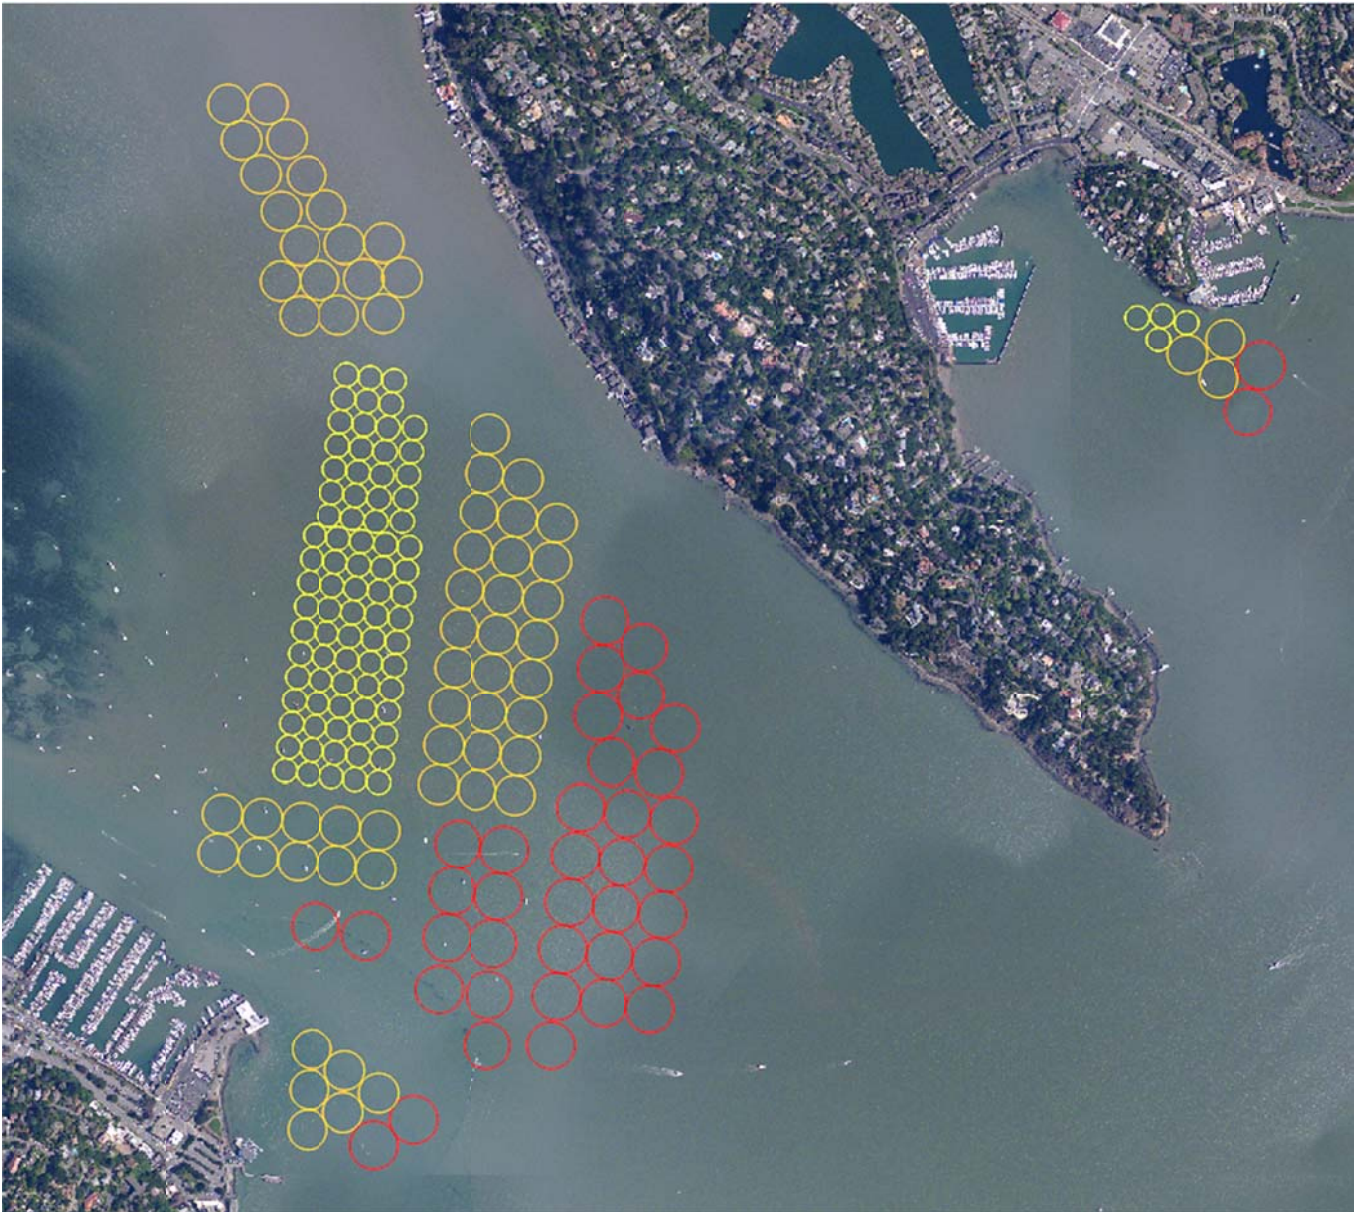
Example configuration of moorings using extremely large radii of 75 feet (yellow), 125 feet (orange), and 150 feet (red). The tight packing of moorings with these larger than required radii demonstrates that capacity for mooring positioning exceeds need or desirability of any of the stakeholder parties. As such considerable flexibility would exist for scaling and adapting mooring locations to address concerns beyond the scope of the present study.
